Lake Gladewater Dam TX03725

Dam Inspection Report

November 2023
Revised: March 2024

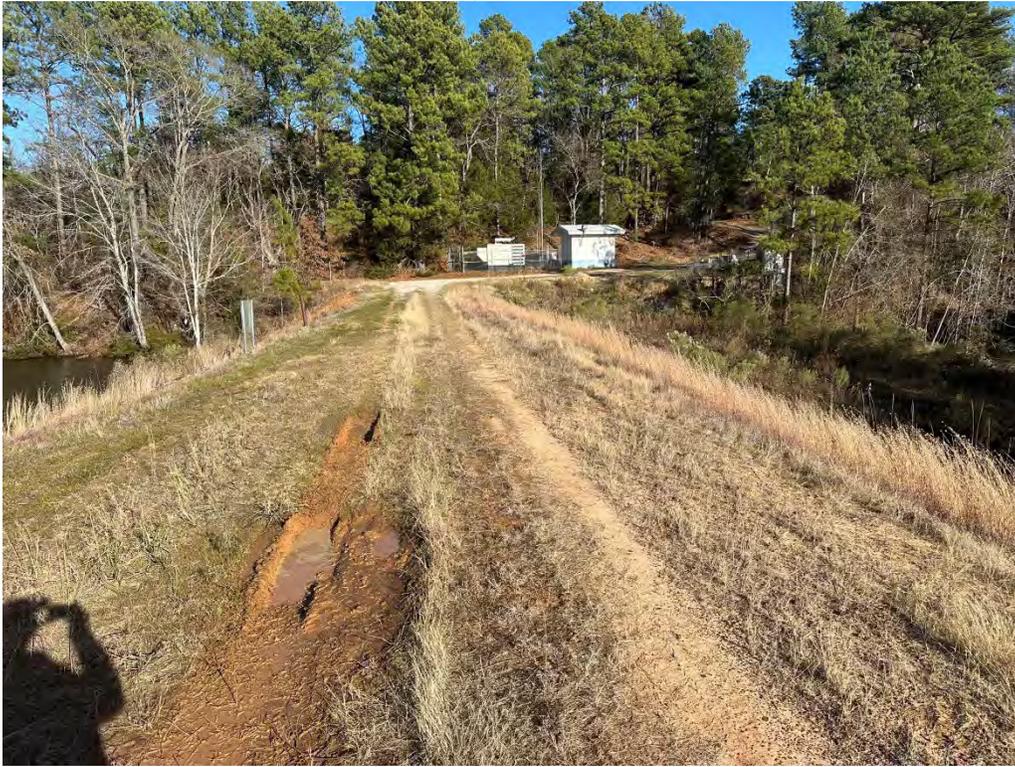
The crest of the dam is in fair condition with a traditional uniform crest elevation. Areas of rutting were present near the raw water intake structure for the Gladewater Water Treatment Plant. These ruts were approximately 8"-12" deep and held water on the crest of the dam. The grass vegetation on the crest of the dam was in fair condition with poor vegetative cover in the wheel paths from vehicles traveling across the crest of the dam. The soil on the crest of the dam consists of iron ore rock and a mixture of clay and sandy material. The overall width of the crest varies from 14-ft to 20-ft wide with an average width of 16-ft.

Photo No. 1 – View facing East. Rutting on crest of embankment.

5. Create and implement an O&M plan to ensure this structure is maintained in an appropriate manner. Some items to consider in the O&M plan include:
 - a. Repair rutting on the crest of the dam

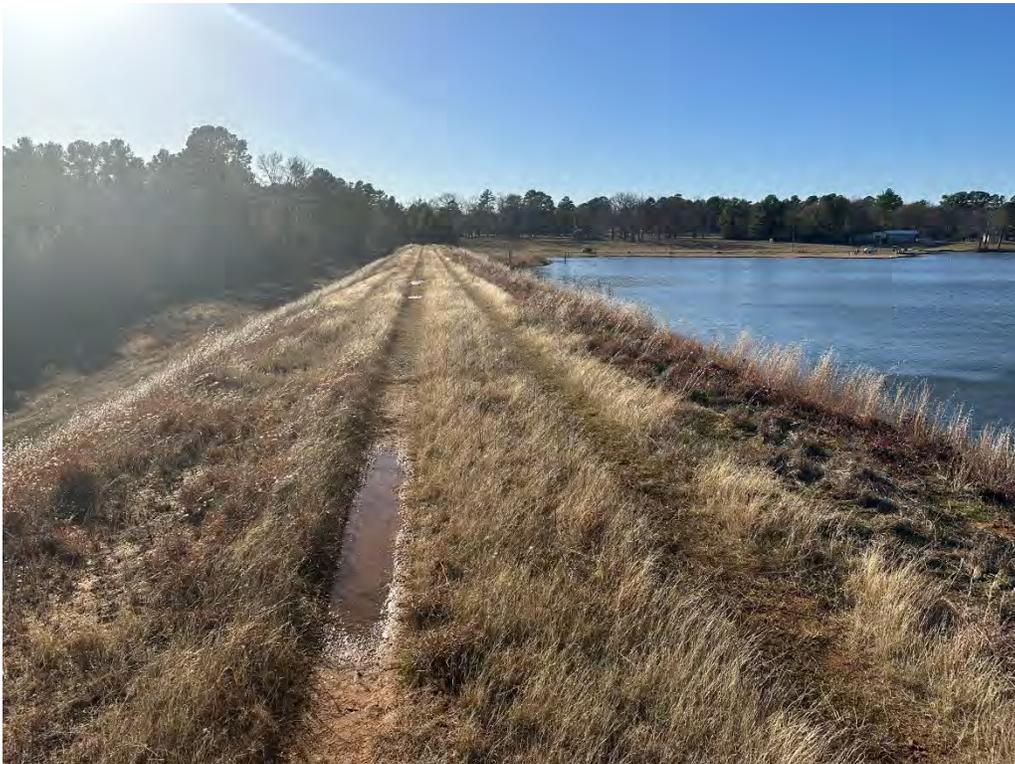
Photo No. 2 – View facing West. Rutting on crest of embankment.

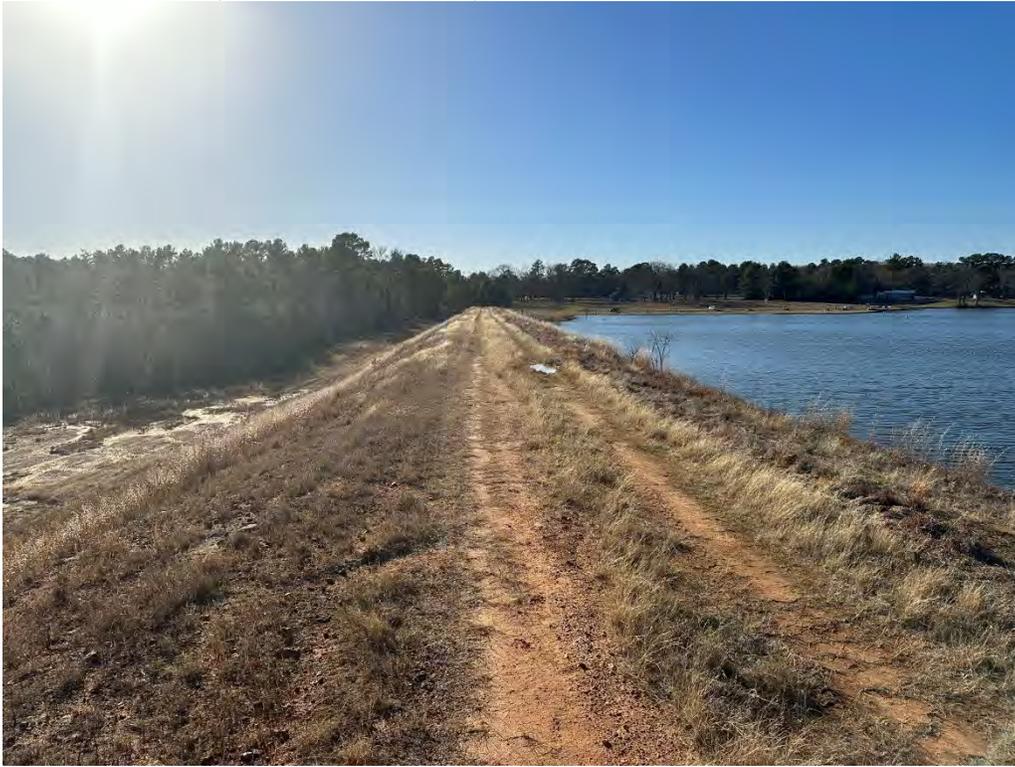
Photo No. 3 – View facing West. Example of lack of vegetation in wheel path on crest of embankment.

- d. Maintain dense grass coverage on slopes and crest of the dam.
 - e. Remove undesirable vegetation from embankments such as trees, thick brush, and weeds. Tall grass should be mowed to facilitate frequent visual inspection of the dam.

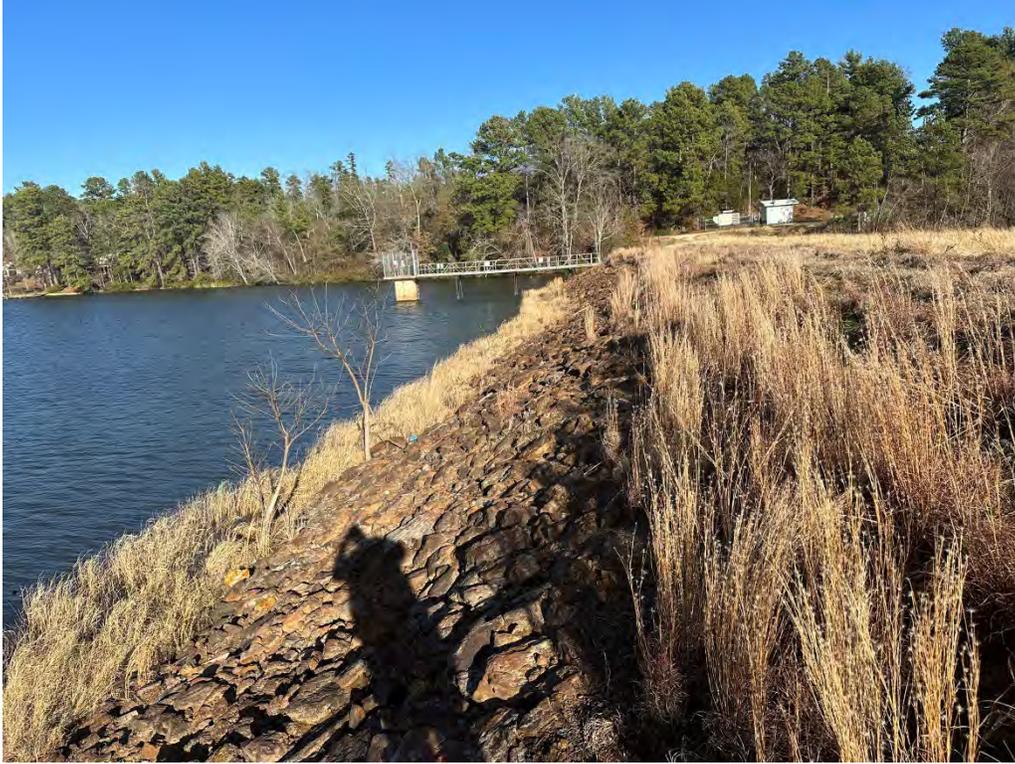
The upstream slope is in fair condition with sparse grass coverage. Rock riprap covers the slope to within 5-ft of the crest of the dam. Sparse grass is growing between the voids of the riprap. Large debris litters the waterline and small trees less than 8' tall are growing near the waterline and in the voids of the riprap. The overall slope is estimated to be 3:1 (H:V). Aquatic weeds and vegetation are present at the waterline of the upstream slope. No animal burrows were identified at the time of inspection on the upstream slope. Significant erosion was noted on the slope underneath the manway leading out to the raw water intake structure for the water treatment plant.

Photo No. 5 – View facing East. Riprap armoring along upstream slope. Dormant Aquatic vegetation at base of riprap.

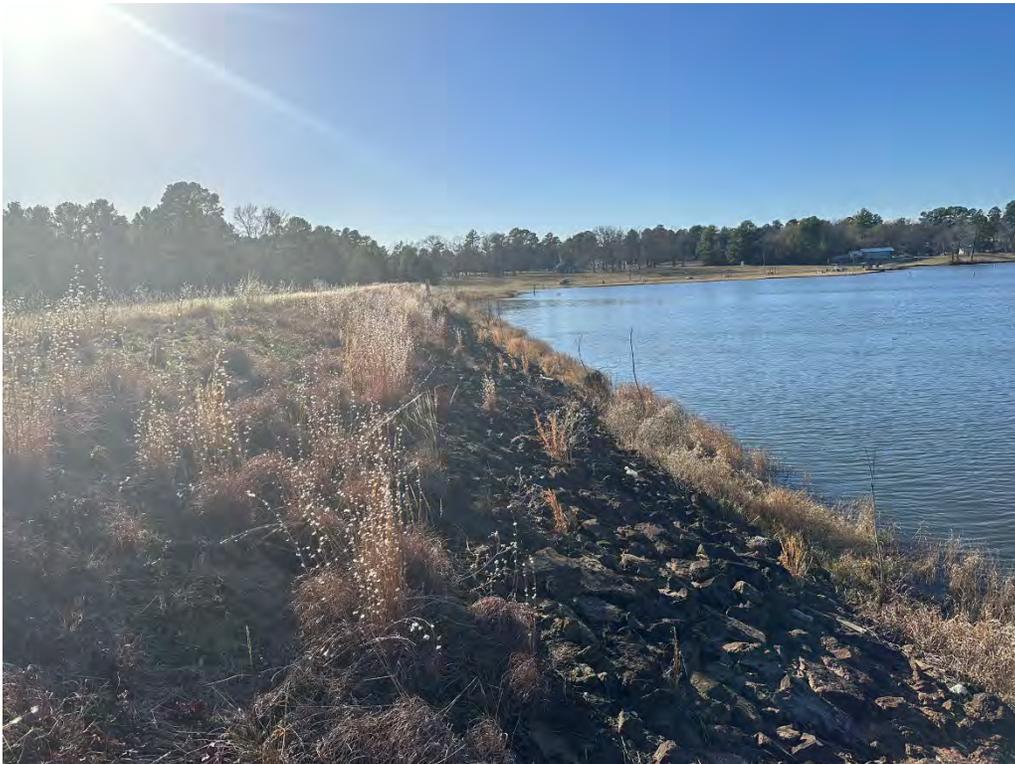
Photo No. 6 4 - View facing West. Riprap armoring along upstream slope. Dormant aquatic vegetation at base of riprap.

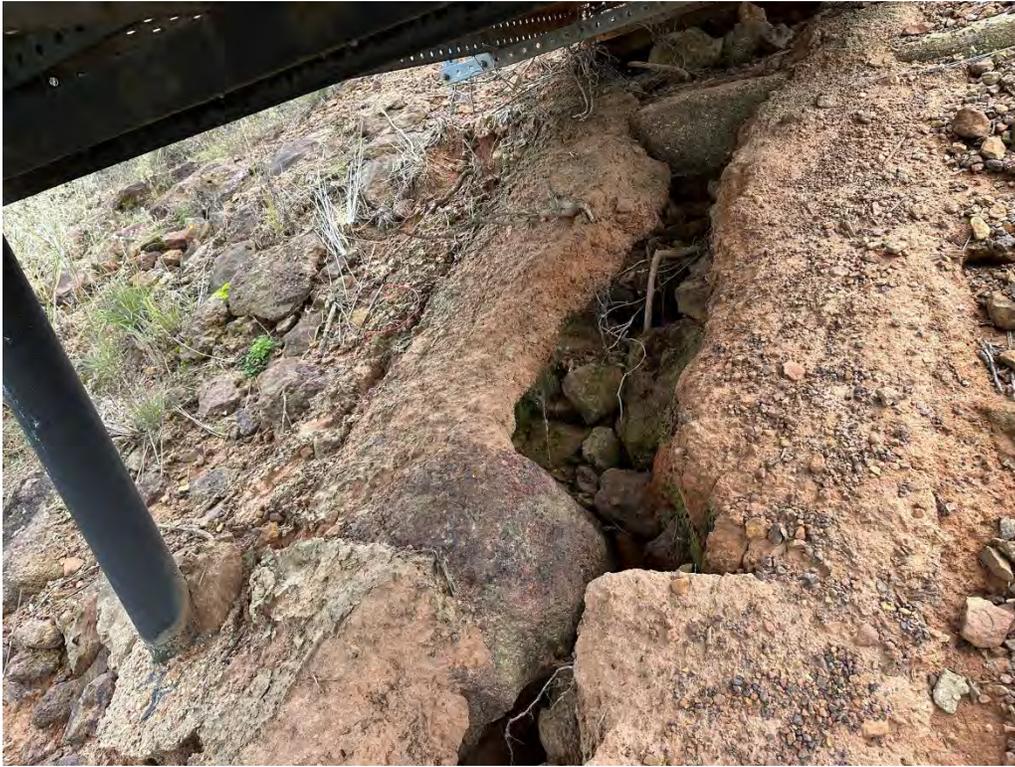
Photo No. 7 - View facing South. Erosion occurring below the walkway for the raw water intake structure

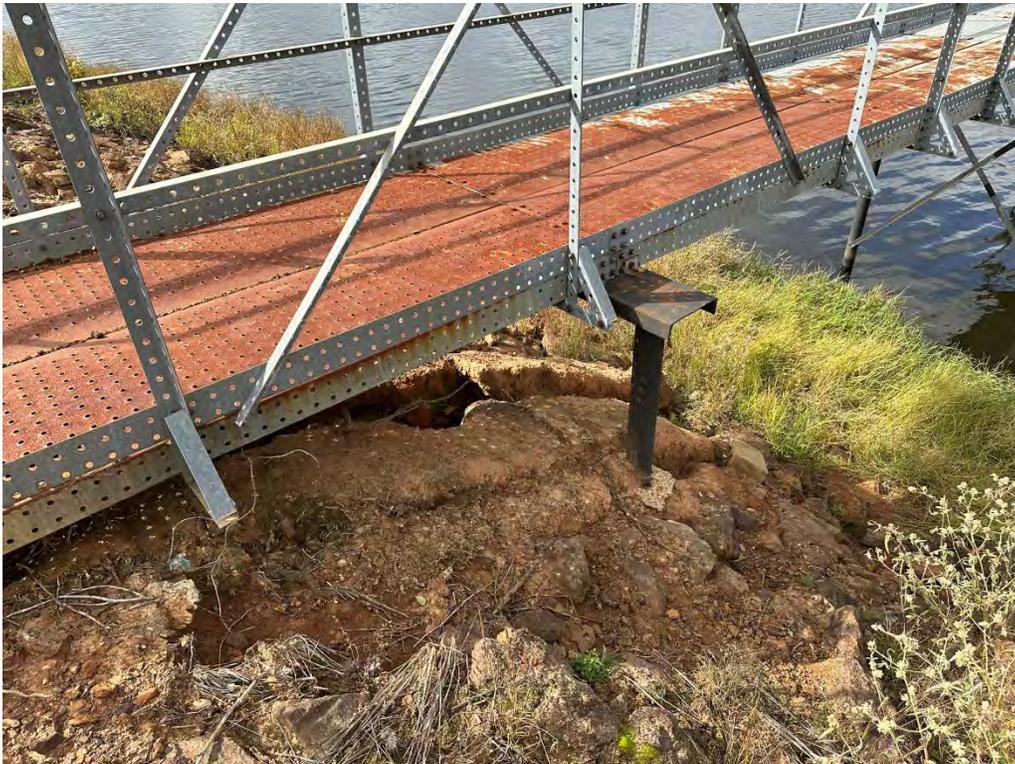
Photo No. 85 - View facing Lake. Erosion occurring below the walkway for the raw water intake structure

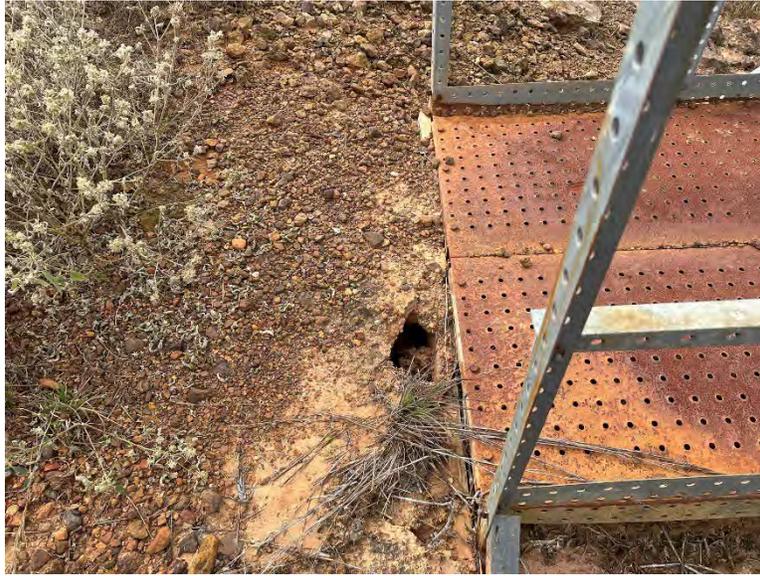
Photo No. 9 - View facing West. Erosion starting to undercut walkway to intake structure.

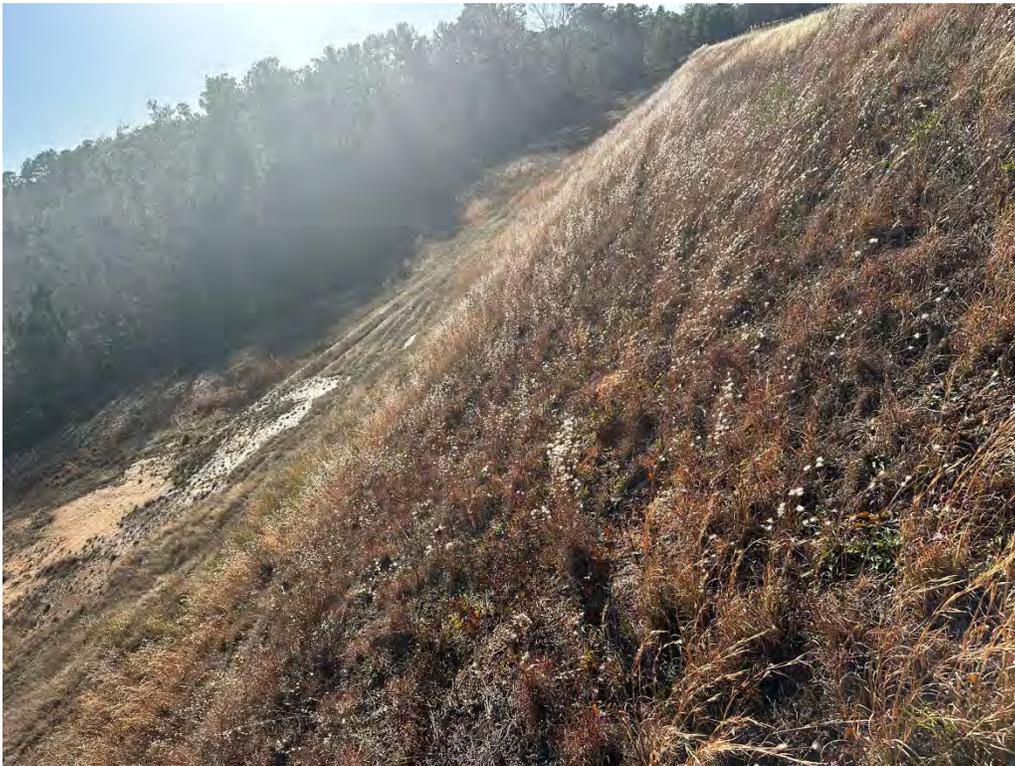
The downstream slope is in poor to fair condition with steep slopes greater than (3:1 H:V) and sparse tall grass coverage with much of the ground between the tall grasses bare and uncovered. Vegetative cover has improved since the 2022 inspection as a result of mowing, but it still remains sparse. The steep slopes are proving to be difficult to maintain with small trees starting to grow as a result. The overall slope varies from as steep as 1.5:1 to as flat as 3:1. Erosion is noted in several areas along the top of the downstream slope. The toe of the slope is dry with no evidence of seepage on the downstream side of the embankment.

Photo No. 60 - View facing West. Downstream slope, dormant vegetation, sparse coverage between stands of plant.

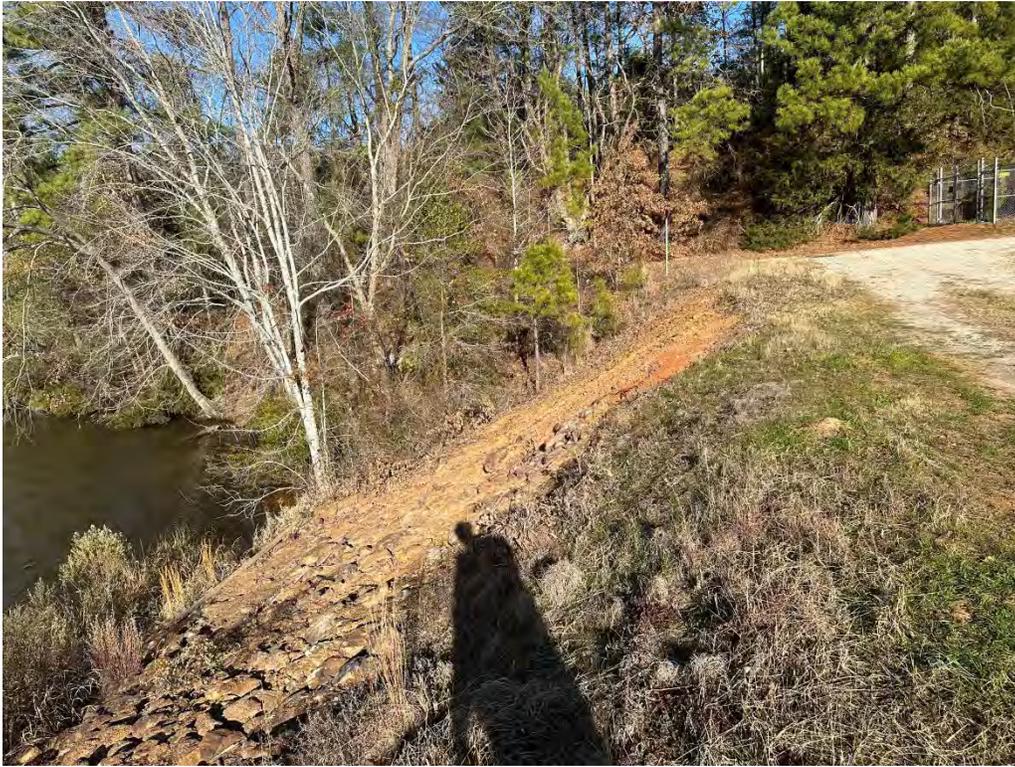
Photo No. 71 - View facing South. Example of lack of vegetation along upstream slope

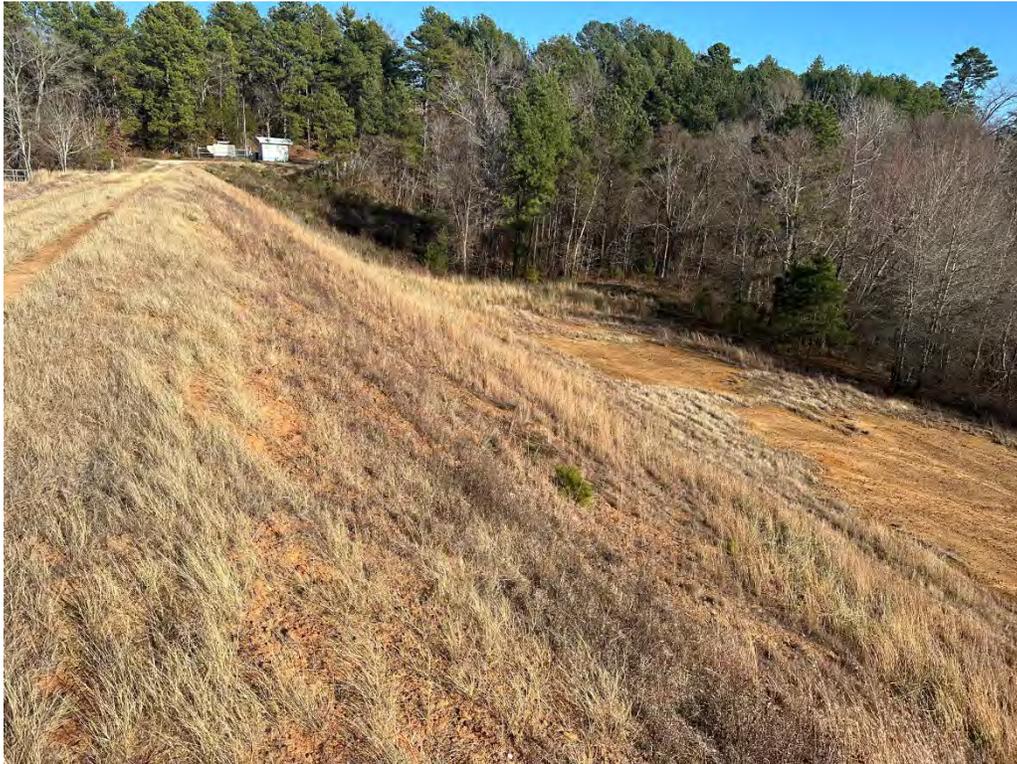
Photo No. 128 - View facing East. Sparse vegetation cover on the downstream slope of embankment & at toe of embankment.

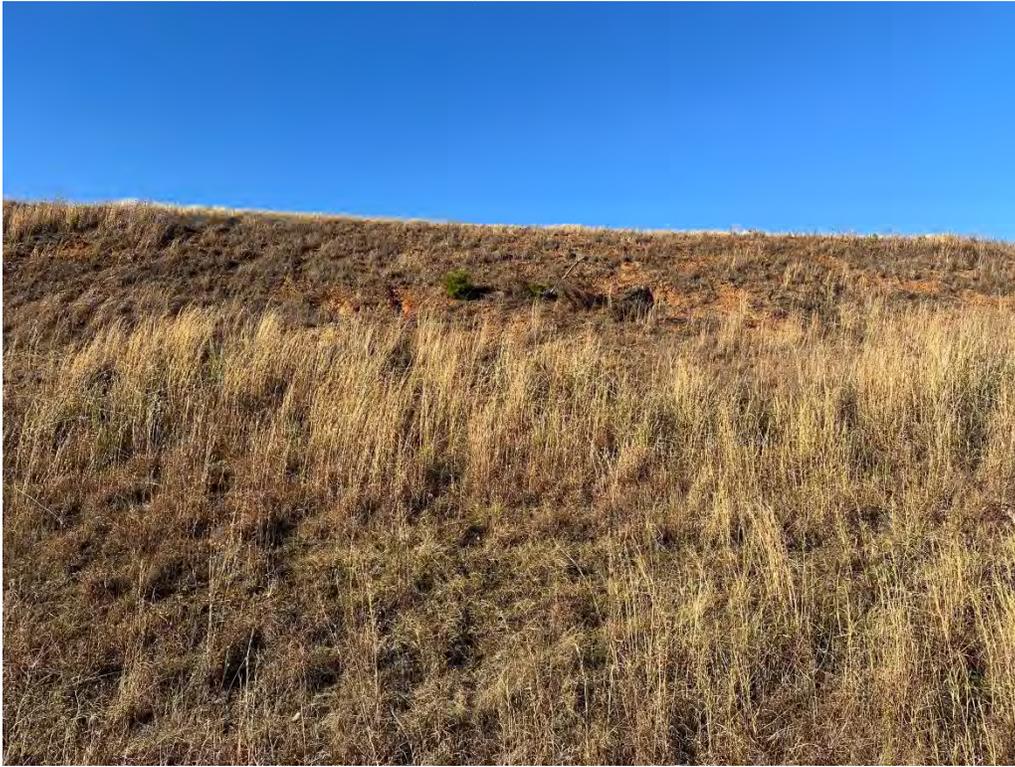
Photo No. 13 - View facing North. Sparse vegetation cover on the downstream slope of embankment. Erosion on slope of embankment

- b. Repair erosion on the intersection of slopes and crest
 - c. Ensure there are no animal burrows present on this structure. If animal burrows or holes are detected, repair should occur immediately.

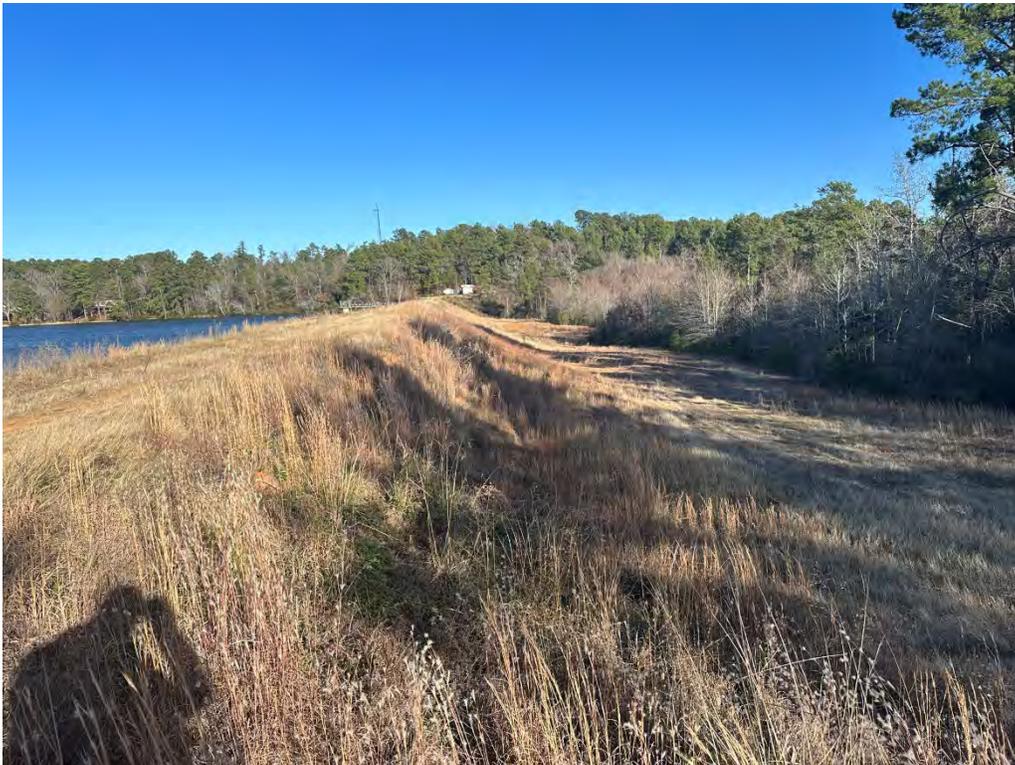
Photo No. 14 - View facing East. Variable slope can be identified in this photo. Top half of downstream embankment is approximately 1.5:1 (H:V) and lower half is approximately 3:1 (H:V).

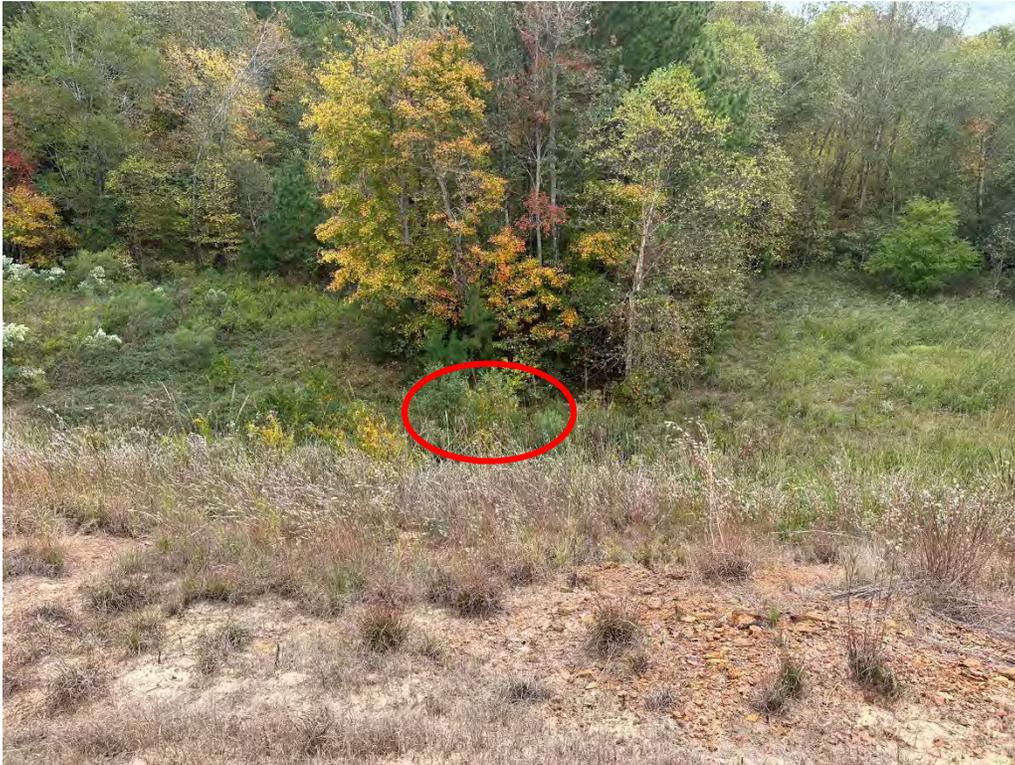
Photo No. 15 - View facing South from top of embankment. Low flow outlet discharge located in trees. Sparse vegetation coverage on slope.

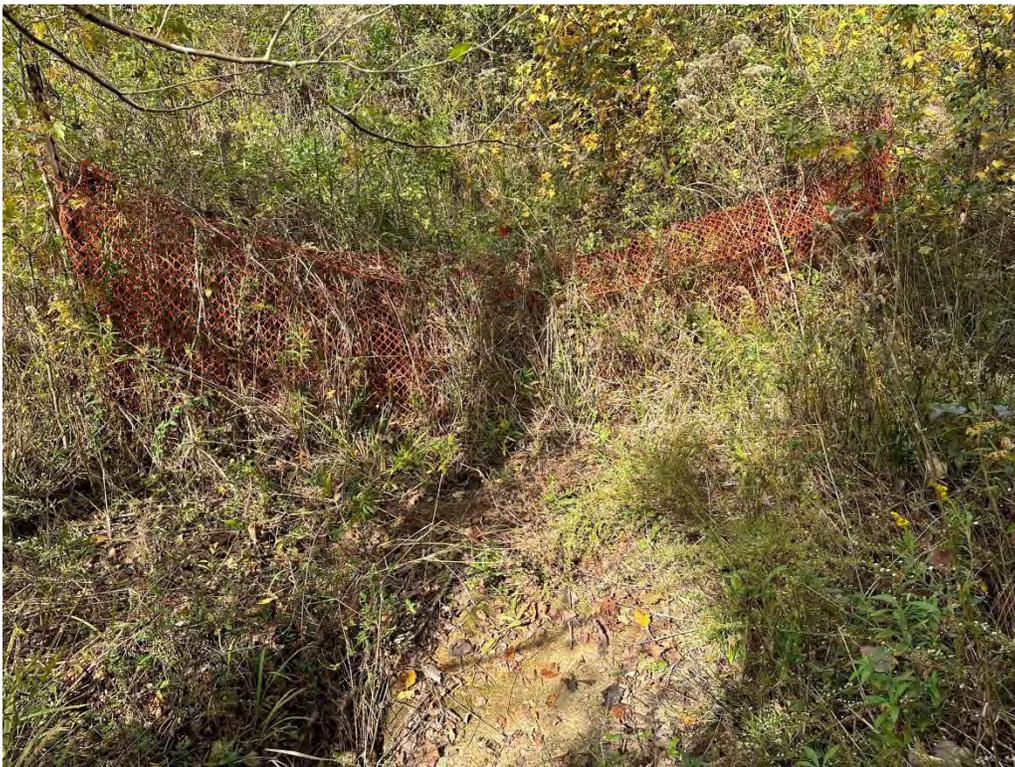
The manually controlled outlet works for the Lake Gladewater Dam consists of a concrete raw water intake structure located near the eastern abutment of the lake with 3 slide gates at different elevations. The intake structure and walkway are in good condition. An 18-inch diameter reinforced concrete pipe extends under the embankment from the intake structure to the raw water intake pumps for the water treatment plant. A gate valve is located in the general area where the low flow underdrain outlet was expected, however, the downstream end of the underdrain could not be located and appeared to be covered by soil and vegetation. The function of the low flow outlet could not be verified. The condition of this outlet is classified as poor as it was not capable of being evaluated.

Photo No. 16 - View facing East. Low flow outlet valve covered by dense brush and small trees. Unable to test operation.

4. Uncover and test the low flow outlet. This structure should be inspected by a PE when uncovered to verify appropriate operation and recommend repairs if needed.

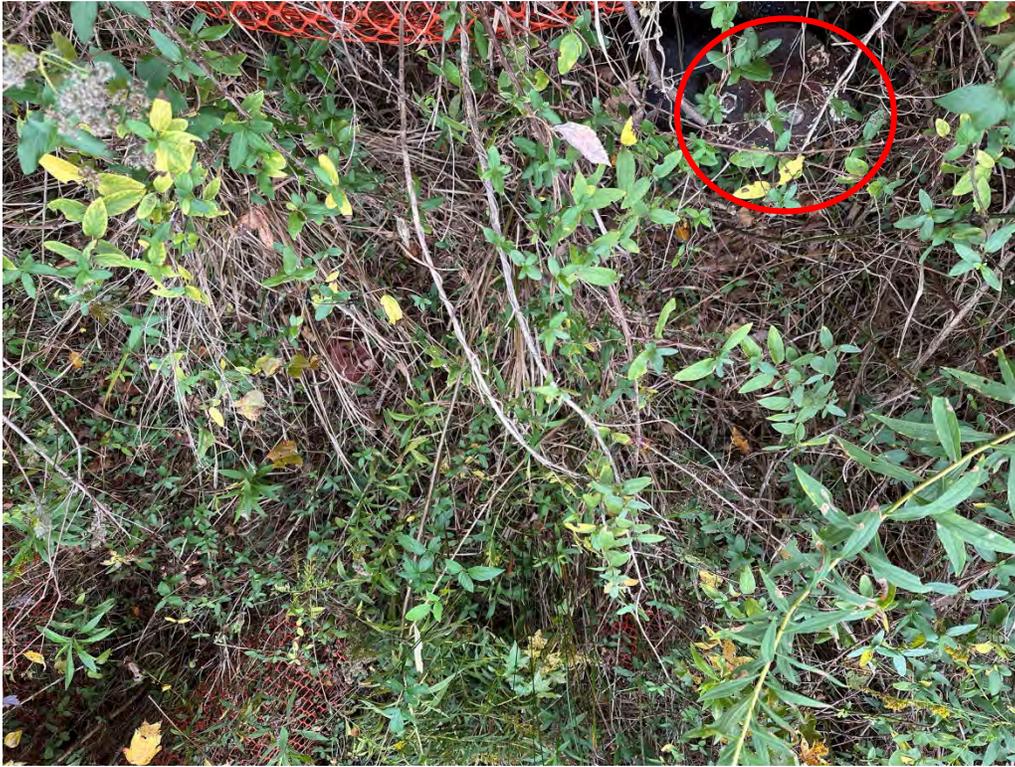
Photo No. 17 - View facing North. Low flow outlet valve.

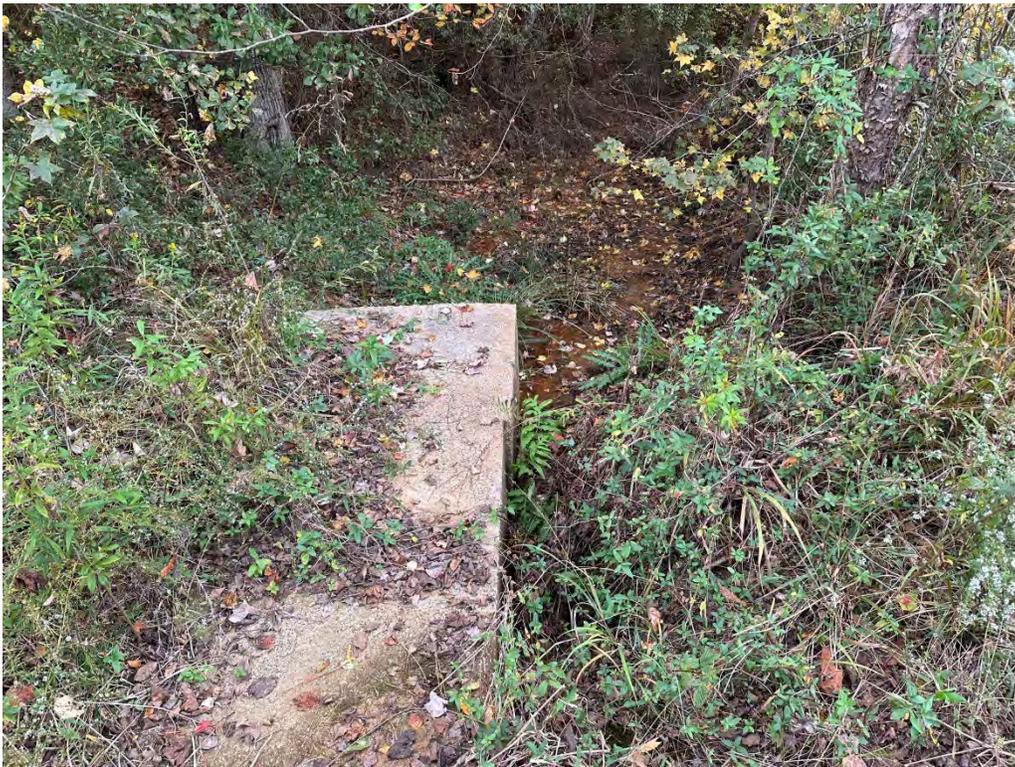
Photo No. 18 - View facing South. Assumed discharge point for low flow outlet. Outfall of pipe is not locatable. It appeared to be inundated in soil and vegetation.

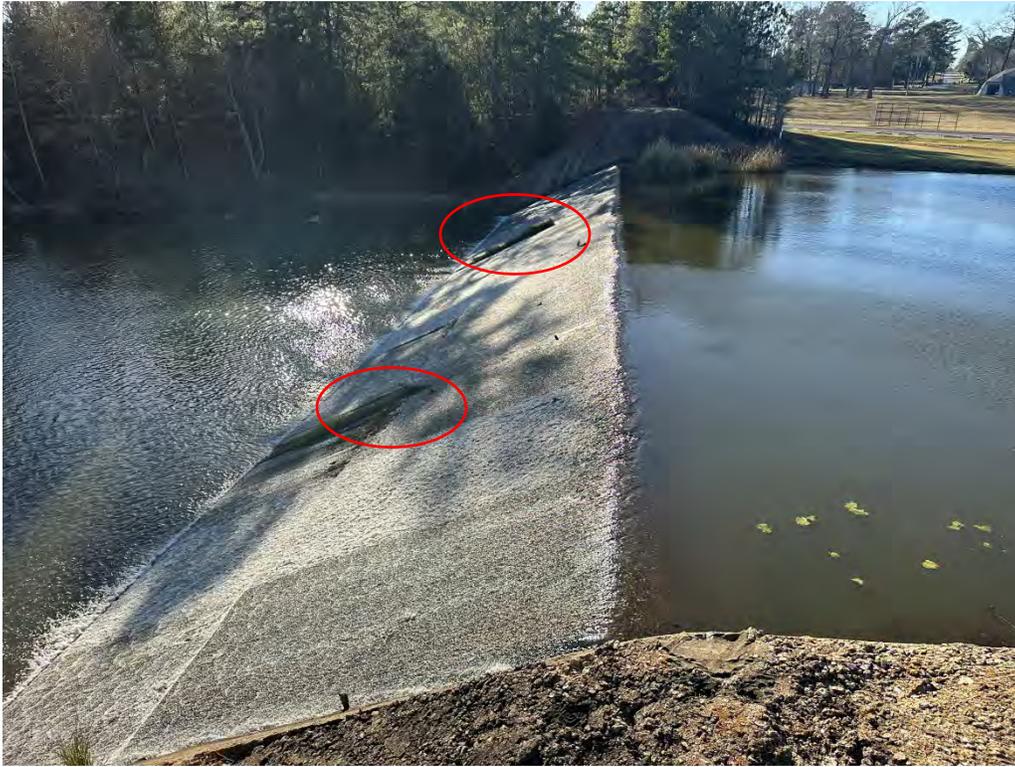
Photo No. 19 - View facing East. Service spillway discharging at time of inspection. Vegetation growing from joints in concrete.

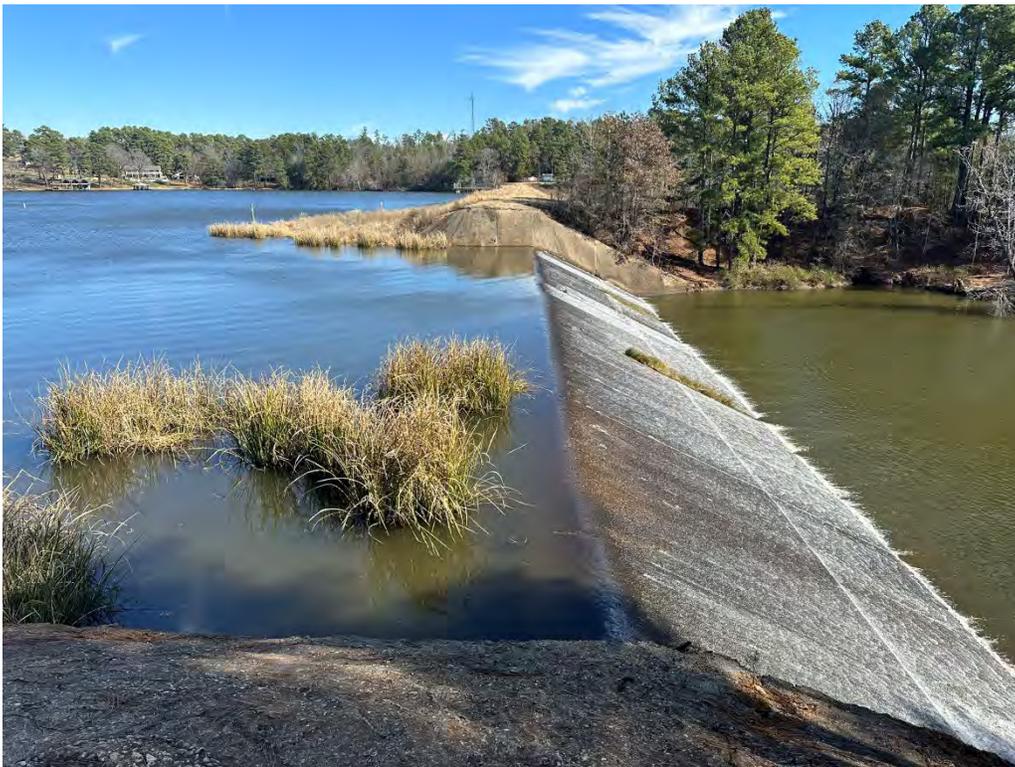
Photo No. 20 - View facing West. Service spillway discharging at time of inspection. Vegetation growing from joints in concrete.

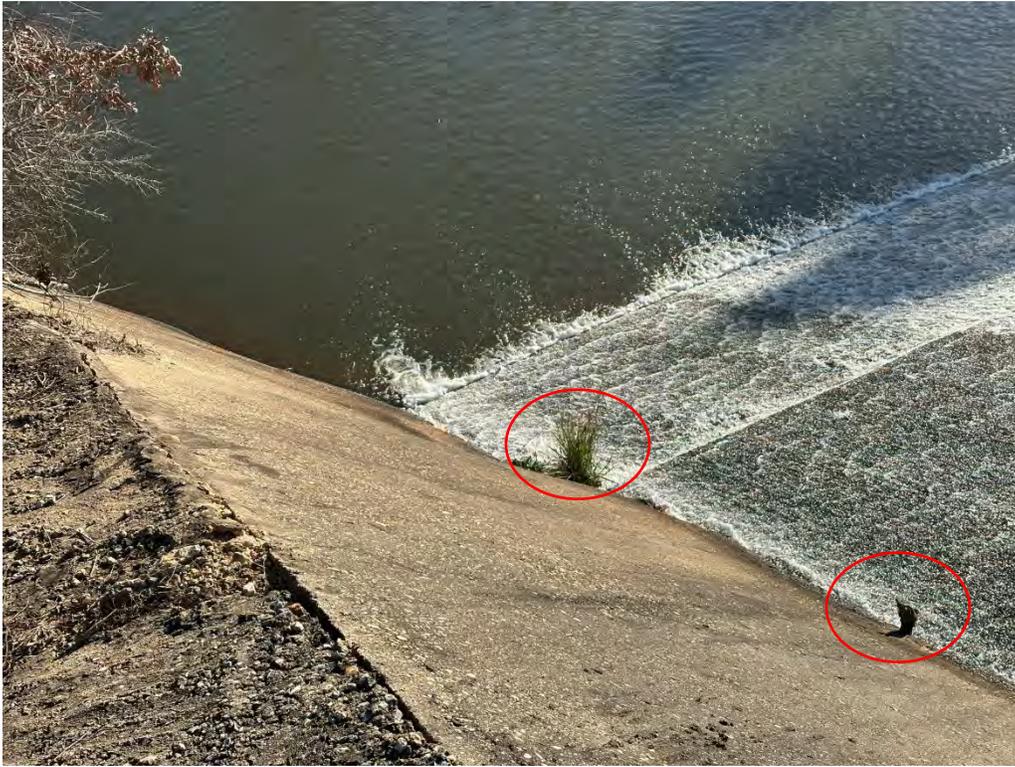
Photo No. 21 - View facing East. Vegetation growing from concrete joints.

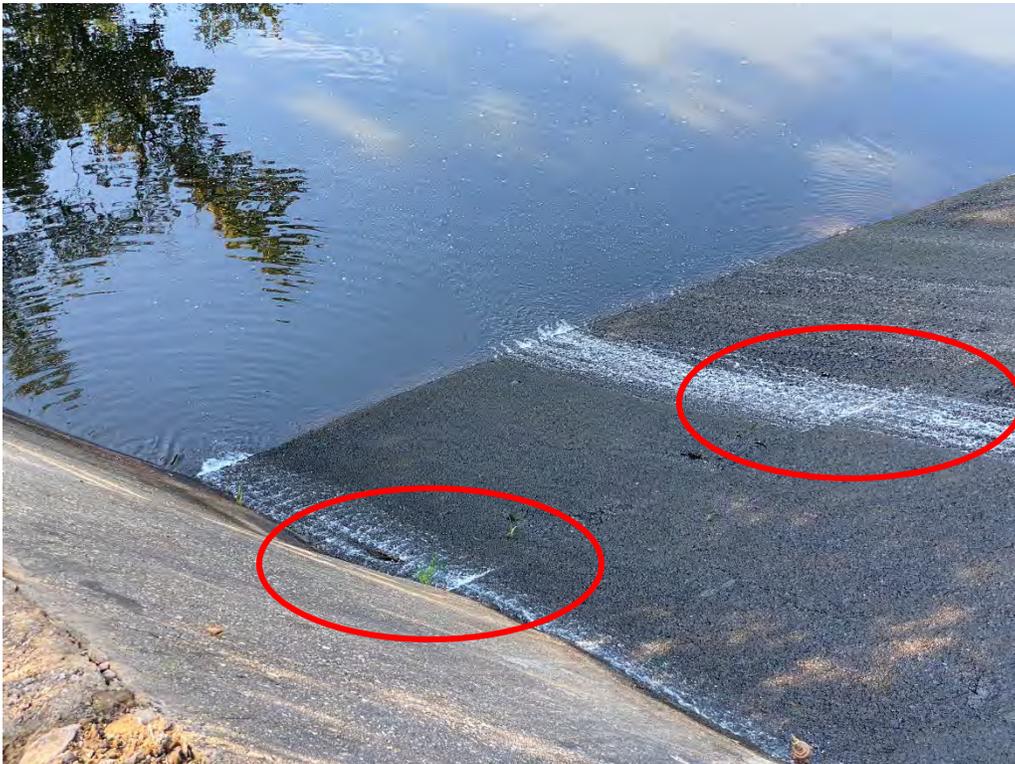
Photo No. 22 - View facing South. Slab misalignment noted.

2. Review and update the EAP and send an updated copy to TCEQ for review.
3. Damage to the concrete spillway structure should be evaluated by a PE and repaired as needed. Construction plans to repair the structure if needed, should be sent to TCEQ for review and approval.

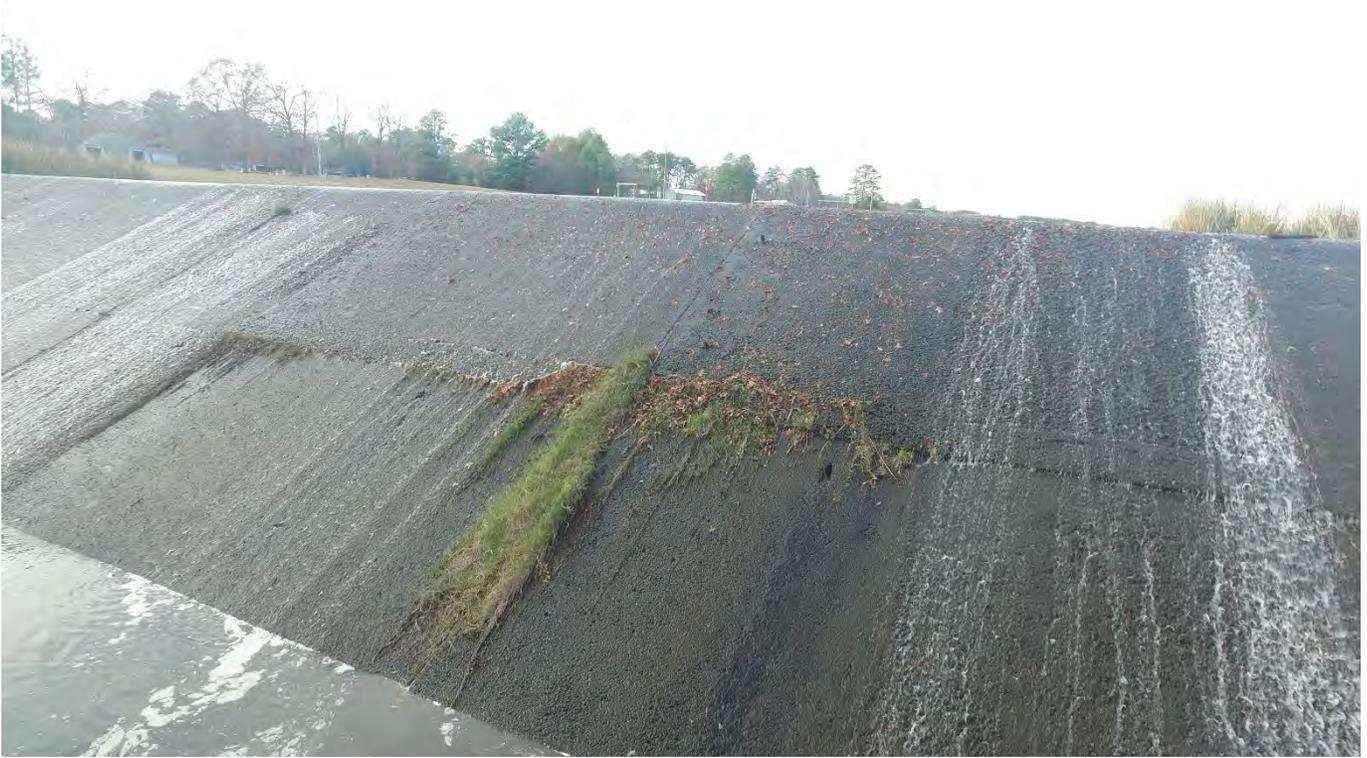
Photo No. 23 - View facing North from Plunge Pool. Vegetation growing in slab joints.

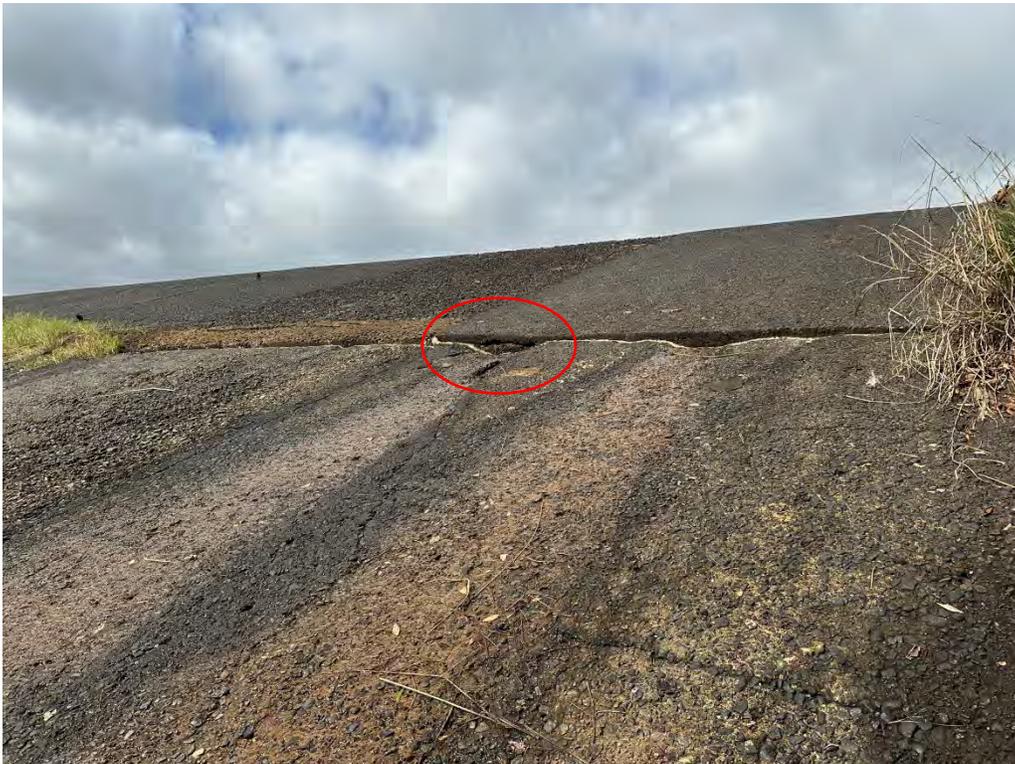
The service spillway appears to be in poor condition. A close inspection was conducted at the time of inspection. The principal (service) spillway is located on the western abutment and is a reinforced concrete trapezoidal weir with a 200-ft bottom width, 1:1 side slopes, and an overall depth of approximately 12-ft. This spillway sits at a normal pool elevation of 300-ft msl. Concrete damage can be seen on both the eastern and western side of the spillway on the lower section near the stilling pools normal water level. Concrete pitting was observed across the downstream side of the structure. Holes and settling were also seen in the slabs of the structure with water jetting out perpendicular to the concrete slabs and vertical separation between adjacent slabs. Water was also observed to be flowing from behind the concrete slabs through the concrete joints. This suggests that

there may be voids present under the concrete slabs. Vegetation was growing in cracks and joints in the concrete slabs. The plunge pool downstream of this spillway structure appeared to be in good condition.

Photo No. 24 - View facing North. Water flowing from concrete joint. Severe pitting in concrete. Vegetation growing from concrete joints.

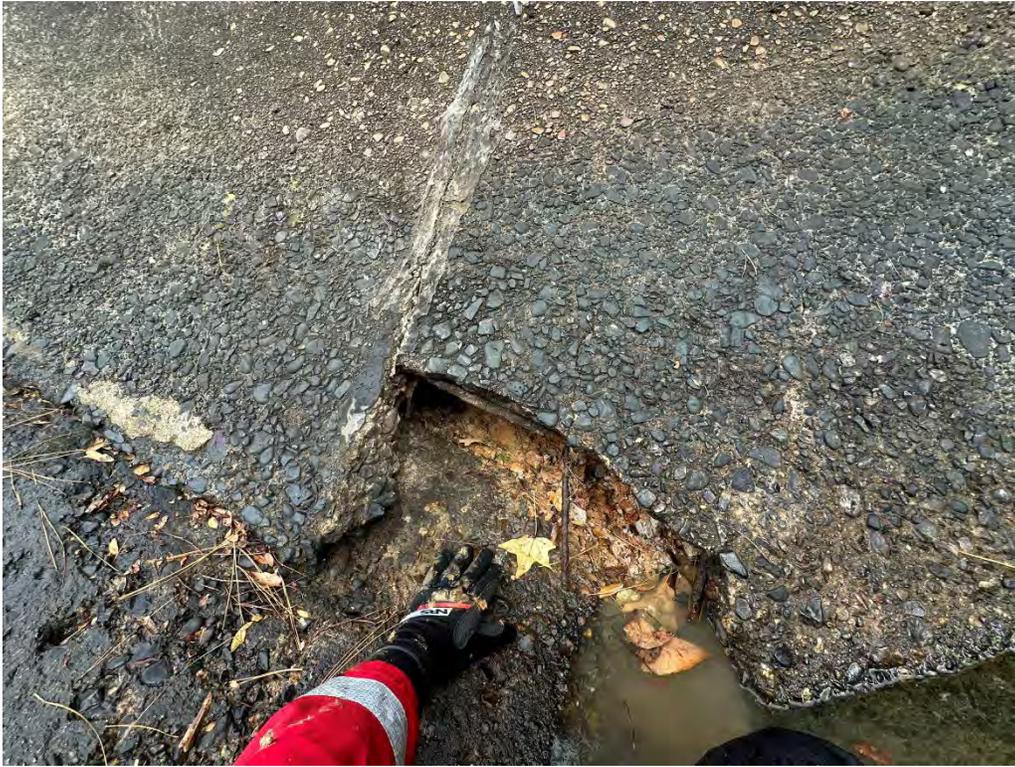
Photo No. 25 - View facing East Abutment. Concrete damage at Plunge Pool normal pool elevation. Approximately 18" long.

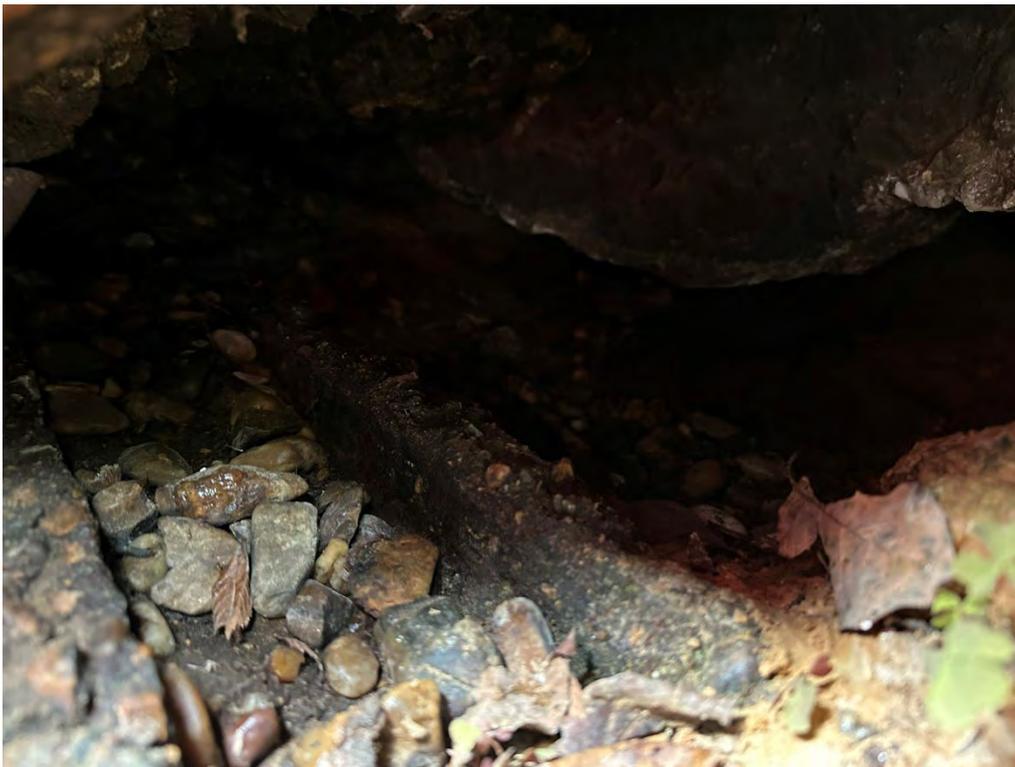
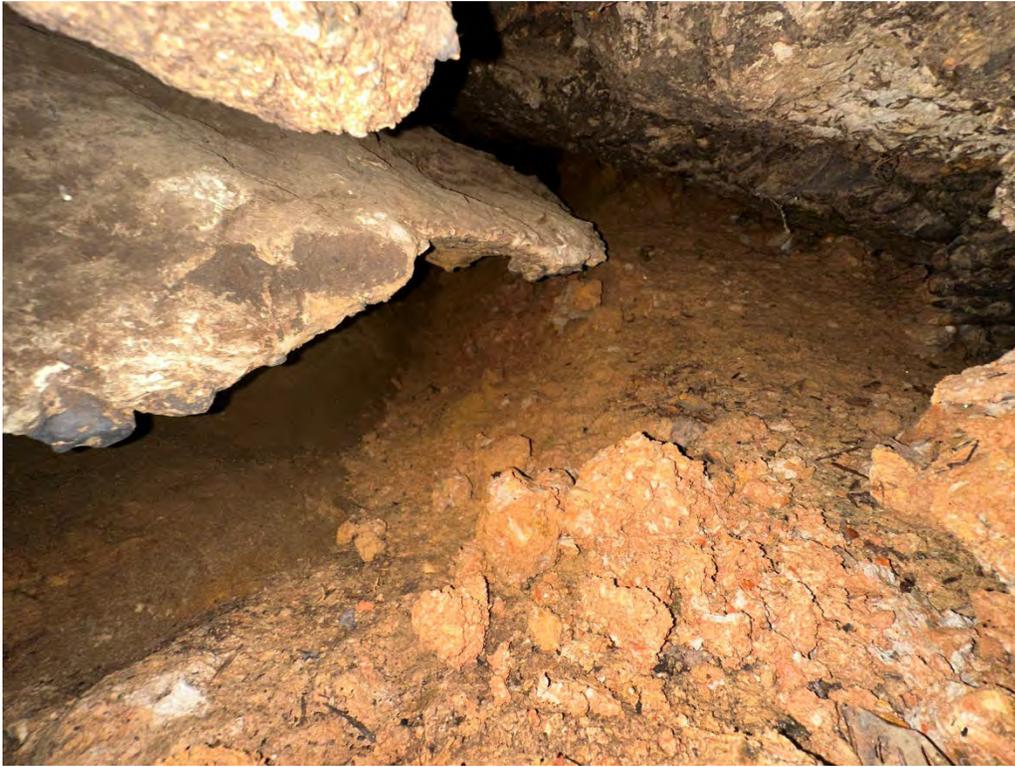
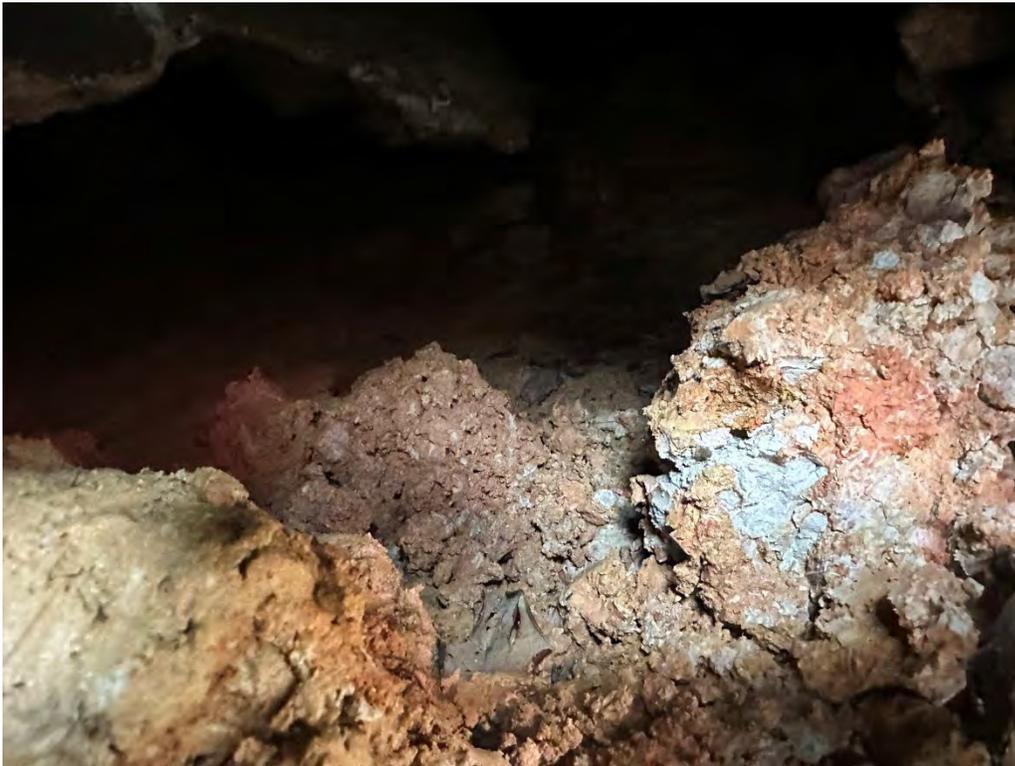
Photo No. 26 – Image inside of concrete damage hole shown in photo 25.
