Lake Gladewater Dam TX03725

Dam Inspection Report

November 2023
Revised: March 2024

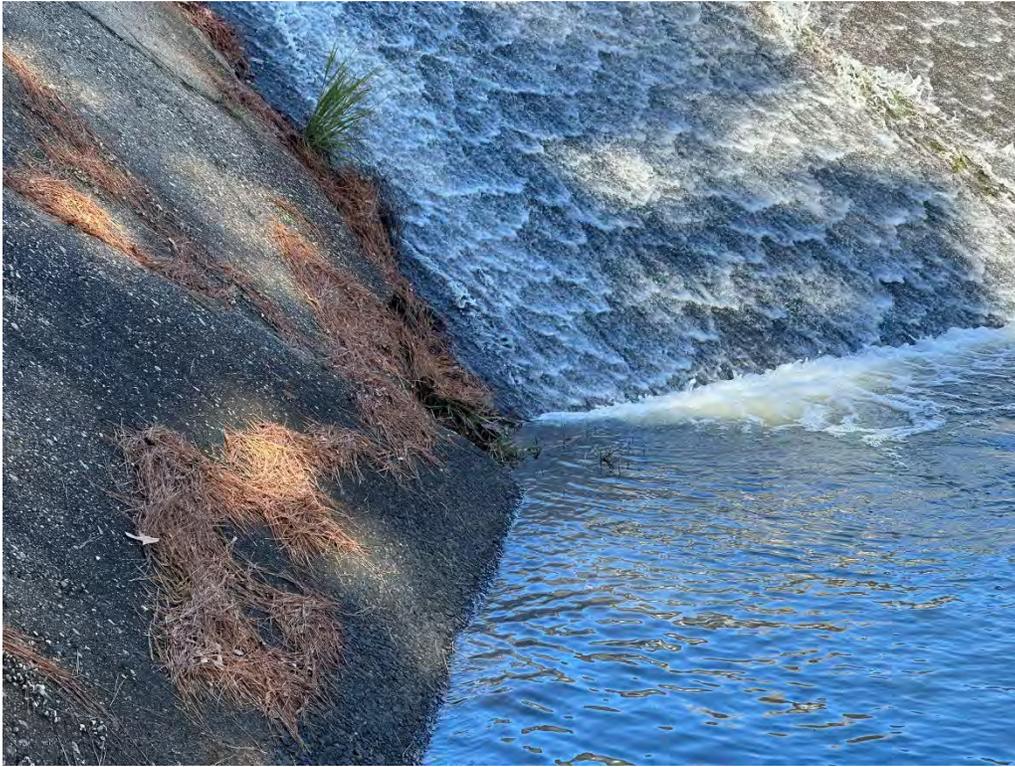
Photo No. 29 - View of West Abutment. Concrete damage at Plunge Pool normal pool elevation.

2. Review and update the EAP and send an updated copy to TCEQ for review.
3. Damage to the concrete spillway structure should be evaluated by a PE and repaired as needed. Construction plans to repair the structure if needed, should be sent to TCEQ for review and approval.

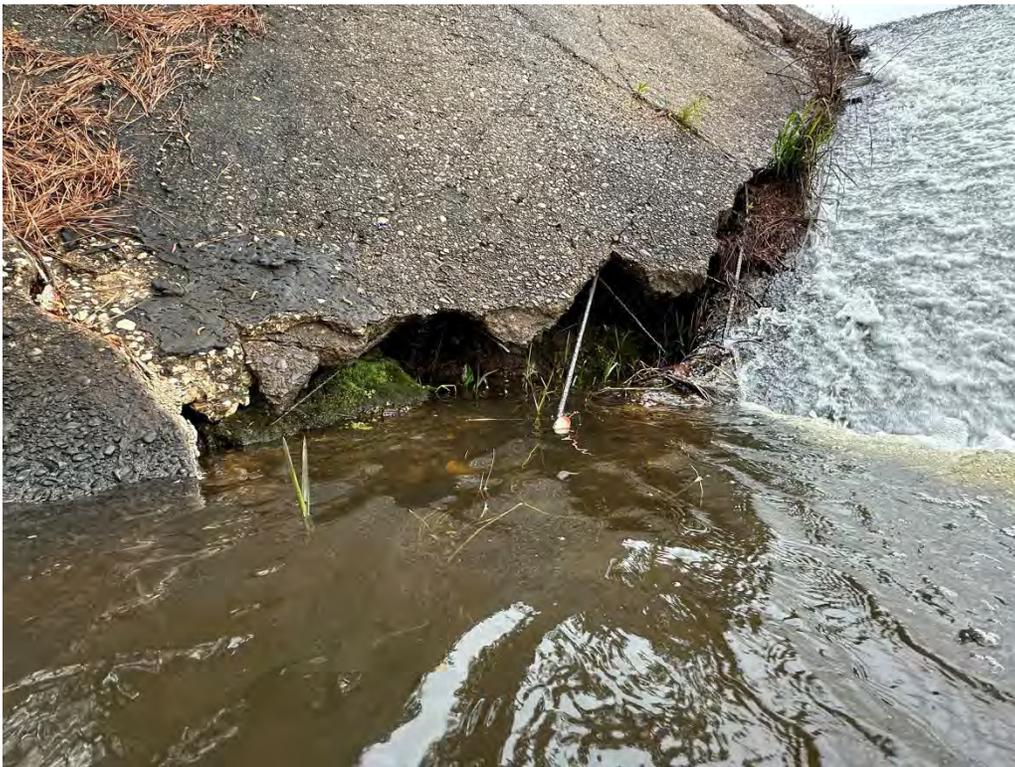
Photo No. 30 - View of West Abutment. Concrete damage at Plunge Pool normal pool elevation.

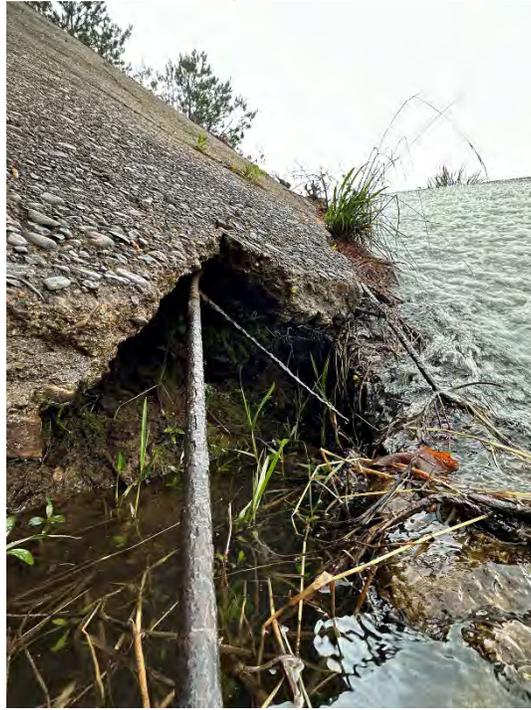
Photo No. 31 - View of West Abutment. Concrete damage at Plunge Pool normal pool elevation.

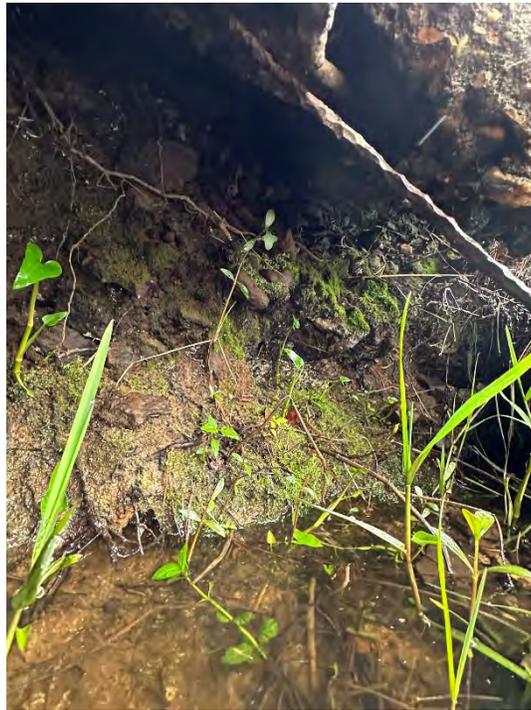
Photo No. 32 - View of West Abutment. Concrete damage at Plunge Pool normal pool elevation. Inside of concrete damage.

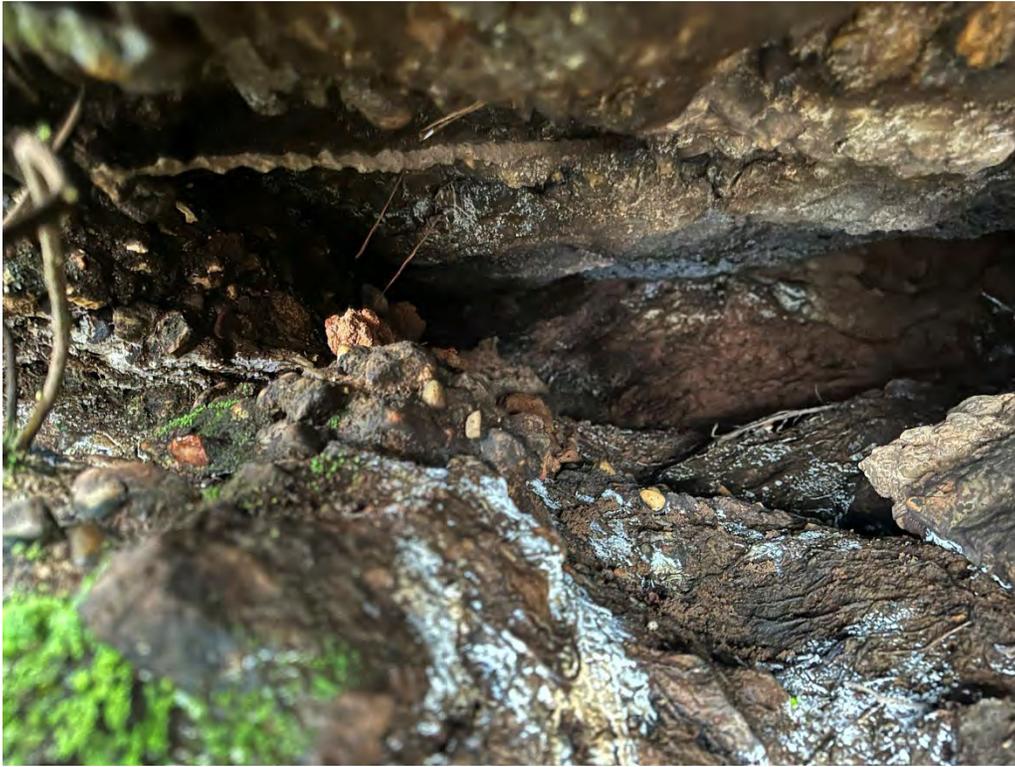
Photo No. 33 - View of West Abutment. Concrete damage at Plunge Pool normal pool elevation. Inside of concrete damage hole.

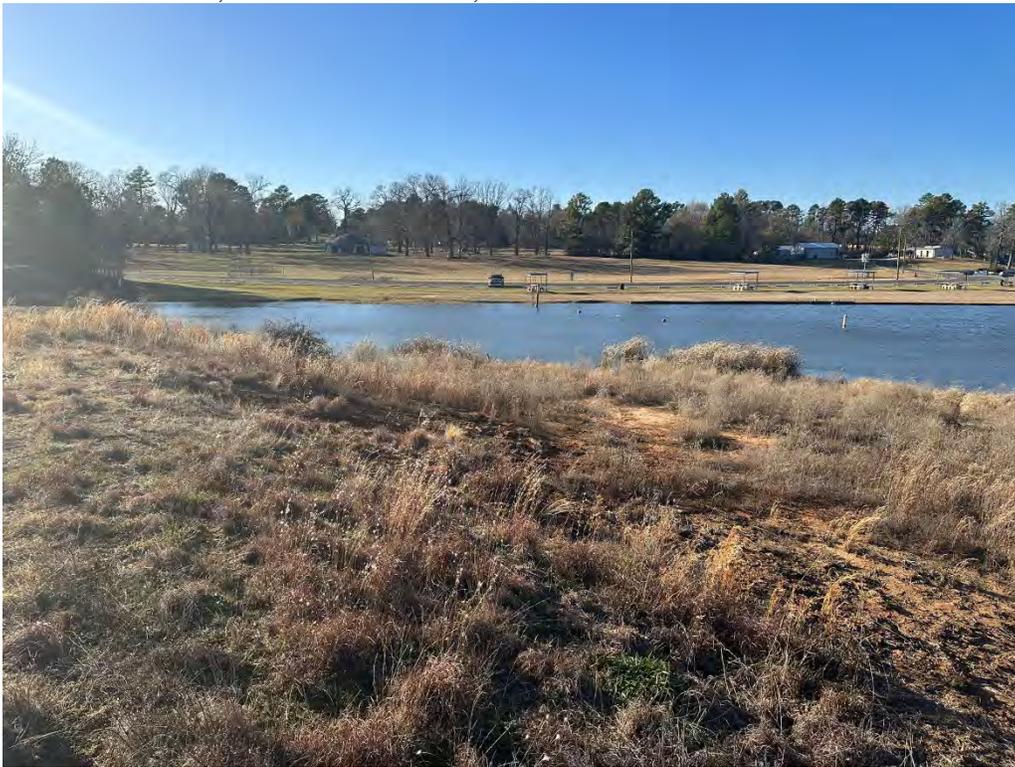
The emergency spillway is in good condition. This structure consists of a 300-ft wide grass-lined trapezoidal shaped open channel spillway. This spillway has a crest elevation at approximately 304-ft msl. Good grass coverage was present throughout the emergency spillway and channel. Park facilities and fencing were present in the emergency spillway at the time of inspection.

Photo No. 37 - View facing West. Emergency spillway across lake. Good vegetation cover, well maintained. Park equipment located in side spillway mouth.
