Lake Gladewater Dam TX03725

Dam Inspection Report

November 2023
Revised: March 2024

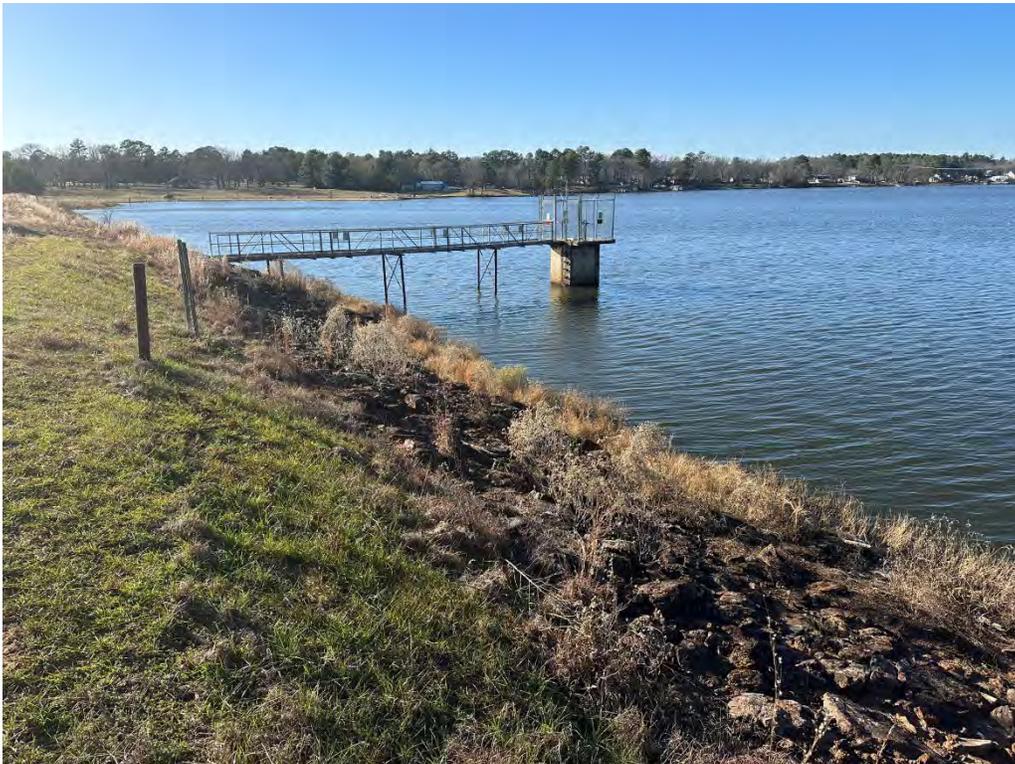
The manually controlled outlet works for the Lake Gladewater Dam consists of a concrete raw water intake structure located near the eastern abutment of the lake with 3 slide gates at different elevations. The intake structure and walkway are in good condition. An 18-inch diameter reinforced concrete pipe extends under the embankment from the intake structure to the raw water intake pumps for the water treatment plant. A gate valve is located in the general area where the low flow underdrain outlet was expected, however, the downstream end of the underdrain could not be located and appeared to be covered by soil and vegetation. The function of the low flow outlet could not be verified. The condition of this outlet is classified as poor as it was not capable of being evaluated.

Photo No. 4 - View facing Lake Gladewater. Raw Water Intake Structure for Gladewater Water Treatment Plant.

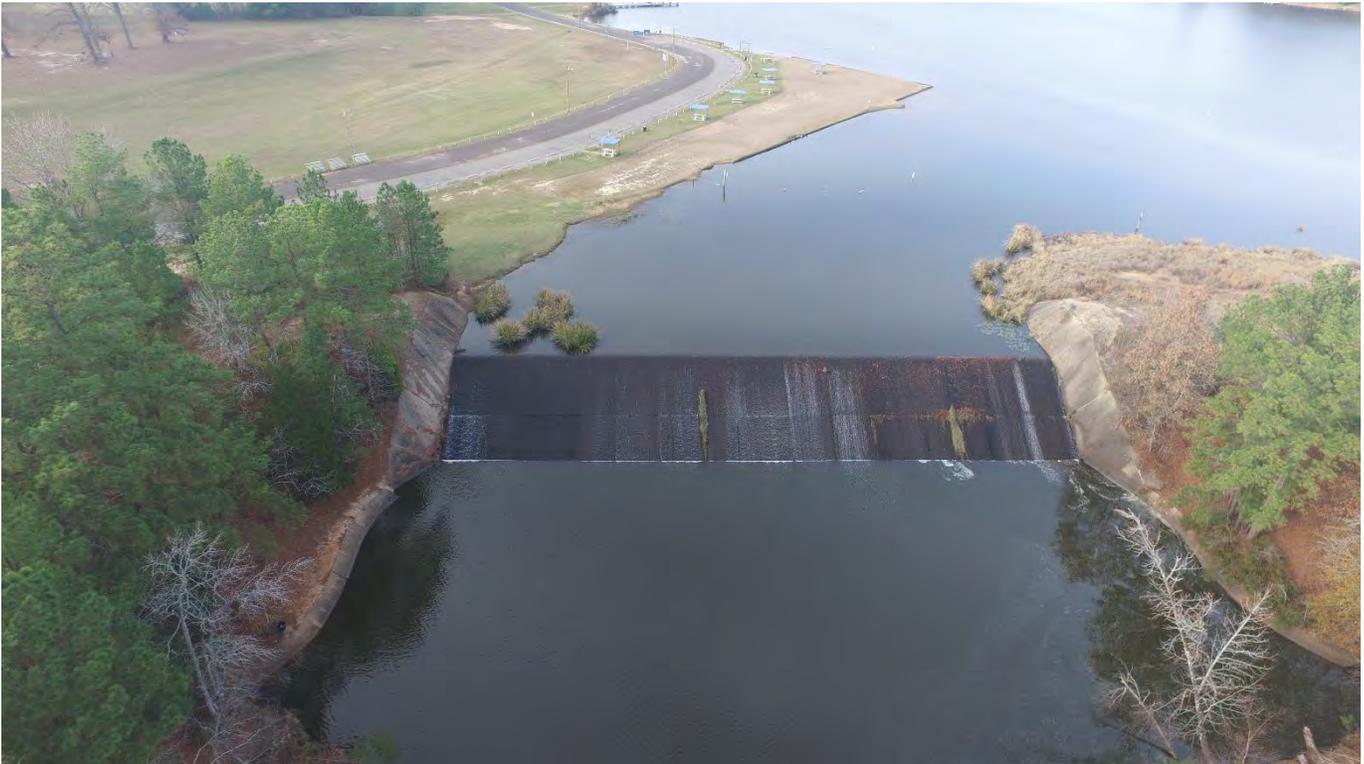
The service spillway appears to be in poor condition. A close inspection was conducted at the time of inspection. The principal (service) spillway is located on the western abutment and is a reinforced concrete trapezoidal weir with a 200-ft bottom width, 1:1 side slopes, and an overall depth of approximately 12-ft. This spillway sits at a normal pool elevation of 300-ft msl. Concrete damage can be seen on both the eastern and western side of the spillway on the lower section near the stilling pools normal water level. Concrete pitting was observed across the downstream side of the structure. Holes and settling were also seen in the slabs of the structure with water jetting out perpendicular to the concrete slabs and vertical separation between adjacent slabs. Water was also observed to be flowing from behind the concrete slabs through the concrete joints. This suggests that

there may be voids present under the concrete slabs. Vegetation was growing in cracks and joints in the concrete slabs. The plunge pool downstream of this spillway structure appeared to be in good condition.

Photo No. 34 – Aerial Image of Principal Spillway.

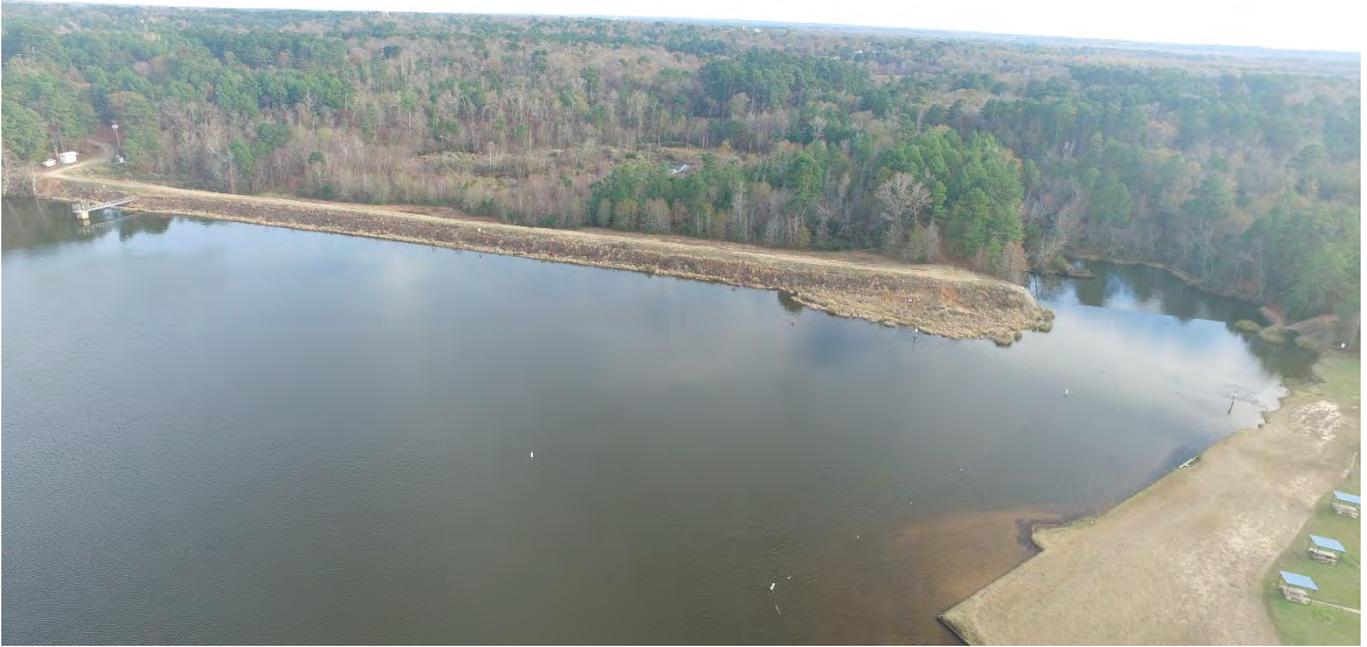
Photo No. 35 – Aerial Image of Lake Gladewater Dam.

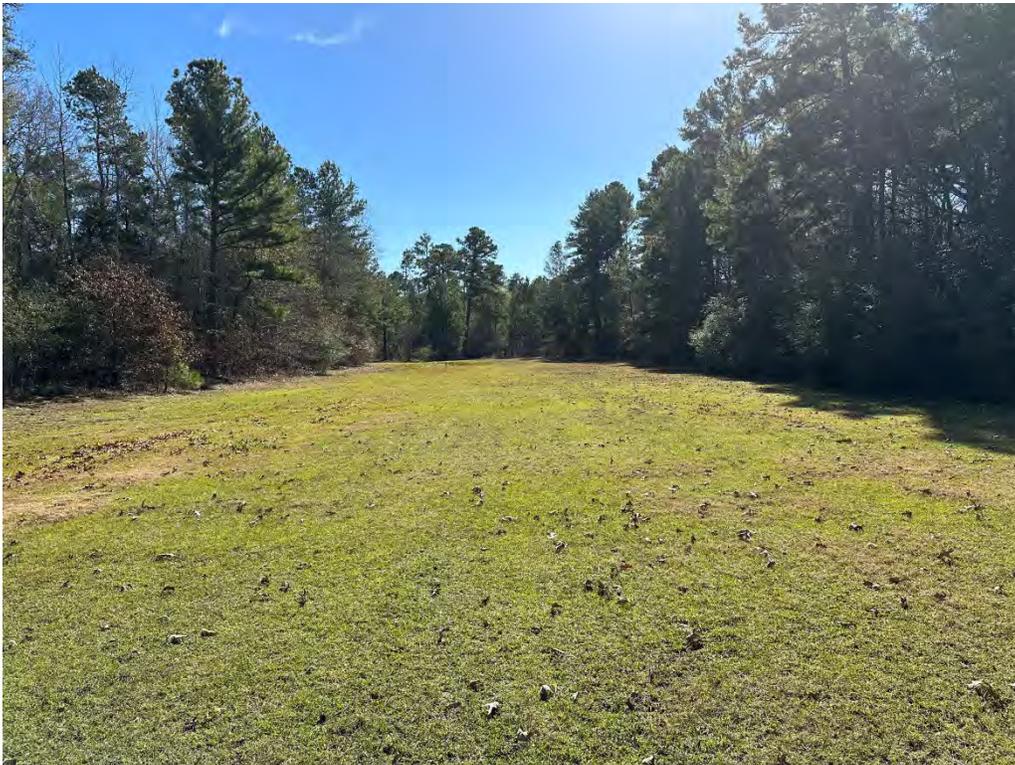
The emergency spillway is in good condition. This structure consists of a 300-ft wide grass-lined trapezoidal shaped open channel spillway. This spillway has a crest elevation at approximately 304-ft msl. Good grass coverage was present throughout the emergency spillway and channel. Park facilities and fencing were present in the emergency spillway at the time of inspection.

Photo No. 36 - View facing North East. Inside emergency spillway channel.
